Manhole Inspection Summary

Manhole # S37W1_011MH

Insp Date: **12/12/07 1:47 PM**

Location Address: **3704 S Hanover St**

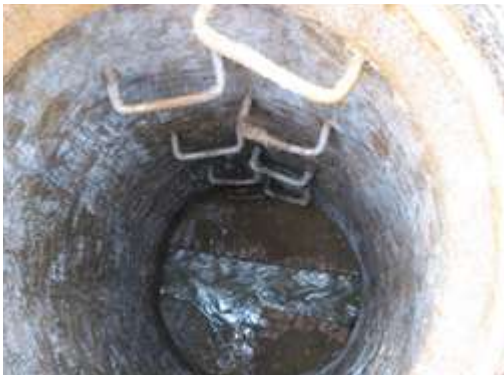
Steps Count: **8** Missing: **0** ☐ Corroded

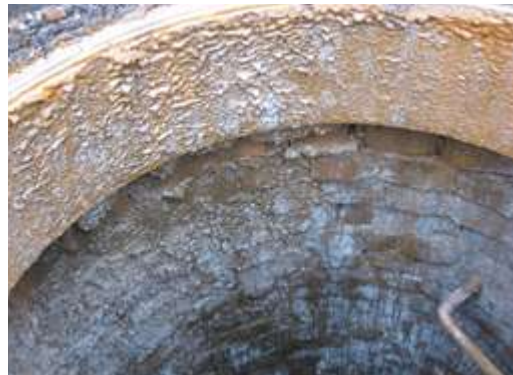
Defect 1

Condition: ☐ Sound ☒ **Cracked** ☐ Root Intrusion ☐ Loose Brick ☐ Deteriorated

Infiltration: ☐ None ☐ Joint ☒ **Cracks** ☒ **Mortar** ☐ Roots ☐ Wall

Cracks/Infiltration chimney/frame adjustment

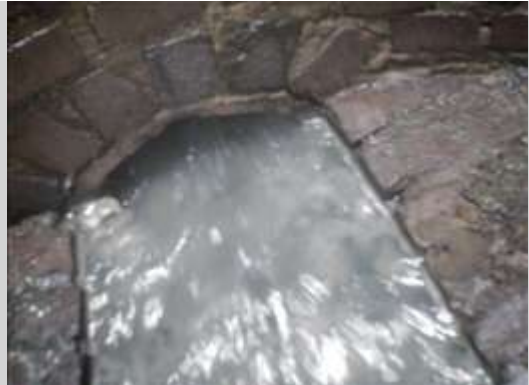
12 O'Clock Outflow

10 in. Circular Gravity Sewer
Pipe Out @ 12 O'Clock

Pipe Height: **9.6** (in.) Rod and Bar (Angled)
Pipe Material: **Clay** ☐ Pipe Lined
Invert Depth: **10.82** (ft.) Flow Characteristics: **Fast**
Deposits: ☐ None ☒ **Mud** ☒ **Sludgy** ☐ Debris ☐ Grease
Silt Depth: **4** (in.) Deposits Extent: **Heavy**
Infiltration: **None** Pipe Seal Cond: **Cracked**

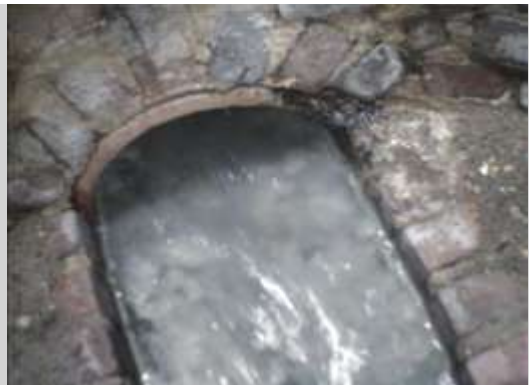
6 O'Clock Inflow

10 in. Circular Gravity Sewer
Pipe In @ 6 O'Clock

Pipe Height: **10.8** (in.) Rod and Bar (Angled)
Pipe Material: **Clay** ☐ Pipe Lined
Invert Depth: **10.74** (ft.) Flow Characteristics: **Fast**
Deposits: ☐ None ☒ **Mud** ☒ **Sludgy** ☐ Debris ☐ Grease
Silt Depth: **4** (in.) Deposits Extent: **Heavy**
Infiltration: **None** Pipe Seal Cond: **Cracked**

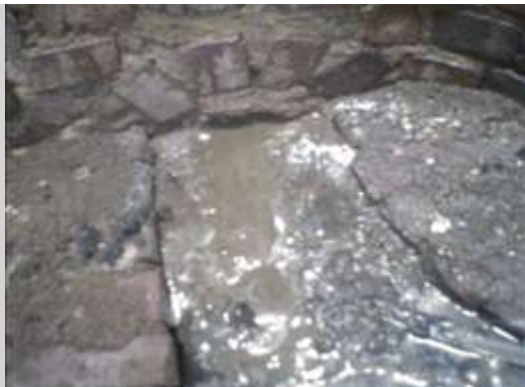
9 O'Clock Inflow

8 in. Circular Service Sewer
Pipe In @ 9 O'Clock

Pipe Height: **8.4** (in.) Rod and Bar (Angled)
Pipe Material: **Clay** ☐ Pipe Lined
Invert Depth: **10.80** (ft.) Flow Characteristics: **Slow**
Deposits: ☐ None ☒ **Mud** ☒ **Sludge** ☐ Debris ☐ Grease
Silt Depth: **8** (in.) Deposits Extent: **Heavy**
Infiltration: **None** Pipe Seal Cond: **Cracked**
